Techline News

How to Find Control Module References in SI2000

Multec 2 Fuel Injector

Transmission Shift Conditions

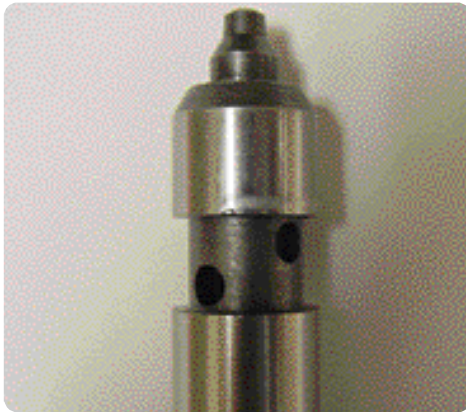
Affects 2000-2001 models equipped with the 4T65E Transmission RPO (M15, MN3, MN7)

Vehicles with the subject condition will exhibit no forward or delayed forward intermittently. Some will not move intermittently when placed in reverse. Putting the vehicle in drive and then back into reverse may alleviate the condition temporarily. This phenomenon has been observed in only a very small number of vehicles in the field.

The cause is a small nick on the forward band piston apply pin (21) that causes the apply pin to stick. Even though the nick may be quite small (no larger than the tip of a sharpened pencil), it may still be sufficient in size to cause the pin to stick. Replace the pin and any associated parts that are required to correct the condition.

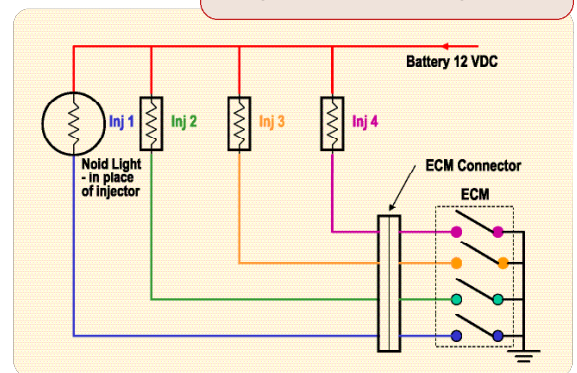
Using J-34730-405 noid light

Delphi also recommends using the injector noid light J-34730-405. When plugged into the connector in place of the injectors, the noid light permits you to verify that power is supplied to the injector and that the injector driver is functioning.

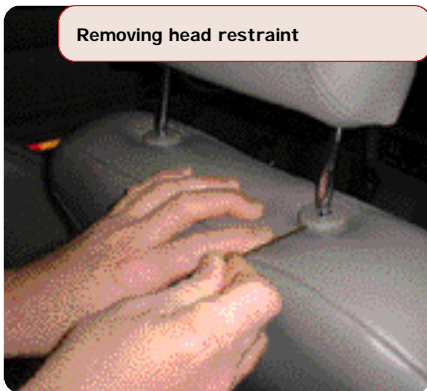
Owners of some 1997-2001 Buick Regal and Century, Pontiac Grand Prix, and 1998-2001 Oldsmobile Intrigue may comment that the head restraint does not stay in position on the seat, but migrates to the full-up position.

Remove the head restraint from the seat back by inserting a small diameter tool into the hole on each retainer and pressing.

Firmly grasp each rod and rotate it 90 degrees. Pull the rods out of the head restraint.

Turn the head restraint over and look into the hole where the head restraint installs to the post. Locate the spring (wire) that fits into the detents on the posts.

Insert a round-shanked tool such as an awl behind the spring and push the tool in, bending the wire toward the hole center. Overbending can either break the spring and/or not allow the post to be reinstalled. Test the operation of the head restraint after installation to assure it's not too tight.
