What Happens When a Radio is Swapped?

Techline News

GM TechLink is a monthly magazine for all GM retail technicians and service consultants providing timely information to help increase knowledge about GM products and improve the performance of the service department. This magazine is a companion to the GM Edge publication.

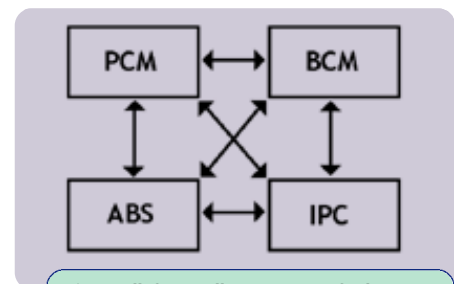
Fig. 1 All Controllers Have U-Codes

The reason each controller has a number of U-Codes pointing at many other controllers is that the controller has come to expect a certain combination of controllers based upon the learned sources for messages which require fail-soft action. These are the State of Health messages (IDs) it has seen, and when these are no longer seen the controller sets the code(s). In this case, after properly initializing, the controller can't see anybody's State of Health message and therefore sets multiple U-Codes.

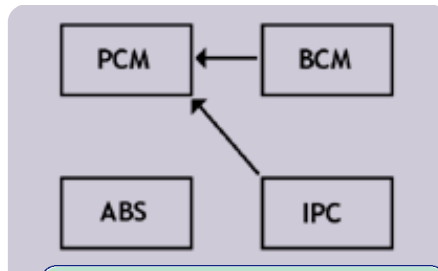
Fig.2 More Than One Box With Same U-Code

When you see the same U-Code stored in more than one box, most of the time it's due to the fact that the controller the DTC is pointing to is no longer able to communicate on the Class 2 bus. For instance if the IPC and the BCM have both stored a U1016 then the IPC and BCM are trying to point to the controller that is at fault, in this case the PCM. It's very important that under these conditions you look for common U-Codes stored among different controllers.

To correct the problem in this scenario you'll have to figure out which controller is unable to communicate on the Class 2 bus, but your detective work should have yielded a suspect. It's now a matter of deciding why the controller is unable to communicate - no power, no ground, open Class 2 circuit, incorrect power mode signals or a defective controller.

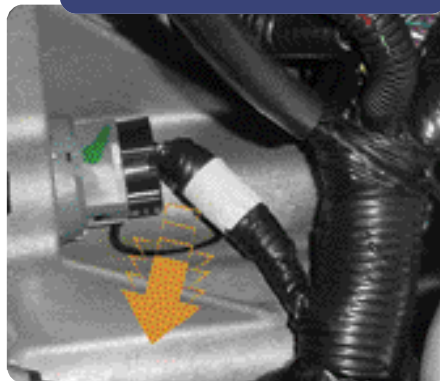
The subject codes may be caused by the wire harness leading to the main transmission connector being routed such that the connector is side loaded. This is analogous to grabbing the harness near the connector with one's hand and pulling to one side. The terminals can get mis-positioned in the connector

Aztek harness indicating direction of side load

and not make good contact. This may result in the codes mentioned. The correction is to re-route the harness such that the connector is not side-loaded.

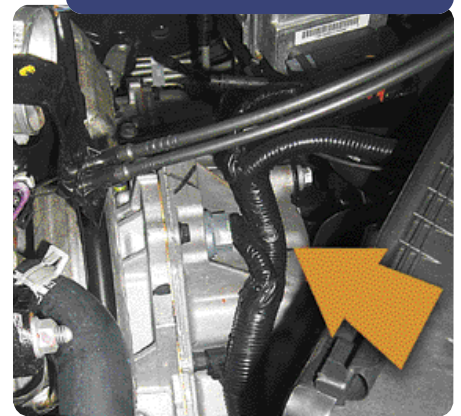
Mis-positioned harness

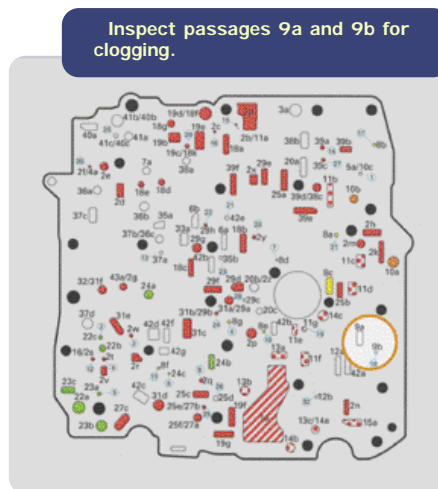
Generally speaking, the diagnostics in the service manual will lead you down the correct path if the code can be reproduced. The one notable exception is that passages 9a or 9b in the spacer plate may clog, setting a code P0741 (this will not set P0742). If normal diagnostics fail to correct a P0741, inspect these passages.
