A monthly publication for GM Dealership Service Professionals

Cam Phasing Technology

**2002 4.2L RPO LL8
(VIN S)**

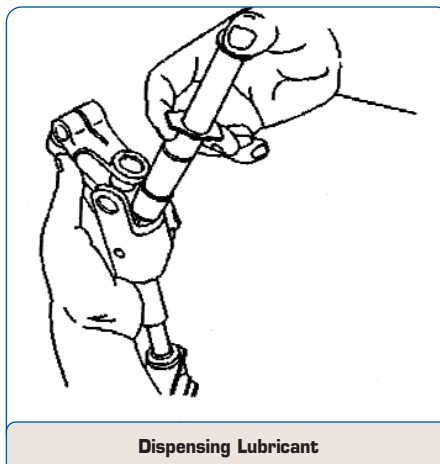
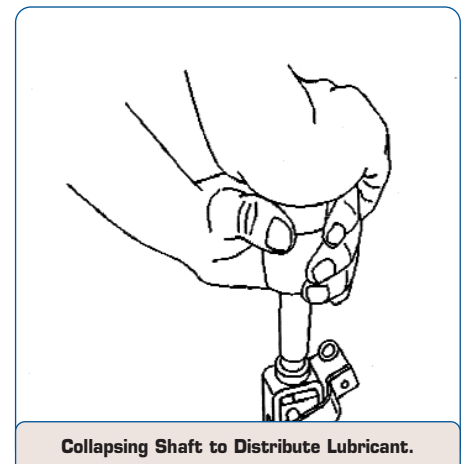
Some customers may comment on a clunk noise from the front of the vehicle when turning. This condition may also be felt through the steering wheel when turned from stop to stop with the vehicle stationary. The clunk may be heard at 180° or 360° of wheel rotation in either direction.

This condition is commonly misdiagnosed as originating in the steering gear. Actually, it may be caused by inadequate lubrication of the steering intermediate shaft.

TIP: Stroke and extend the shaft at least 15 times before installing to the vehicle.
