Techline News

How to Find Control Module References in SI2000

Multec 2 Fuel Injector

Transmission Shift Conditions

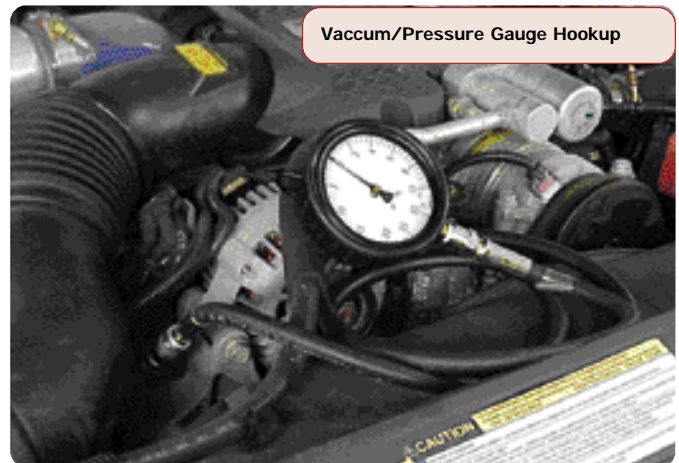
The vacuum/pressure gauge is also useful when diagnosing the Duramax 6.6L diesel. In the case of a complaint of "starts, runs, then dies," or if the vehicle will not start after sitting for a period of 30 minutes or longer, hook up the vacuum/pressure gauge to the schraeder valve on the right front valve cover to

determine if air intrusion into the fuel system is the root cause of the complaint. With the vacuum/pressure gauge hooked up, prime the fuel manager until 10 psi is reached. If pressure does not reach 10 psi after twenty or so pumps, air intrusion is the cause. Refer to the fuel system diagnostic in the manual.

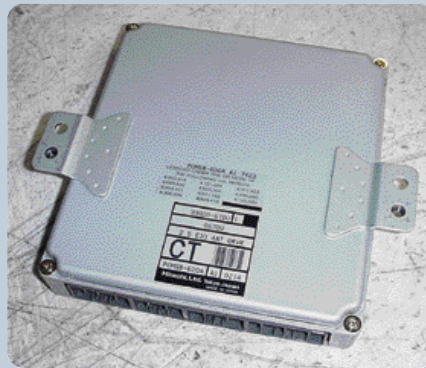
Rough/Unstable Idle During Engine Warm Up -- Bulletin 00-06-04-013, issued in March 2000, addresses a rough idle condition on 1999-2000 Trackers with manual transmission. Customers may comment that the vehicle runs rough when idling with the clutch depressed after a cold start, before the coolant reaches normal operating temperature. The actu-

al idle speed may drop below the desired speed. Reprogramming the PCM is the proper correction for this condition.

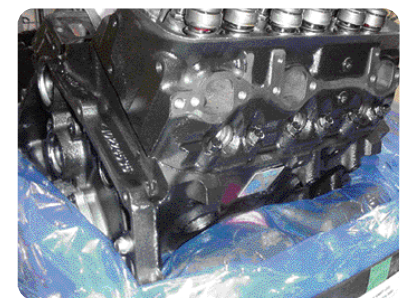
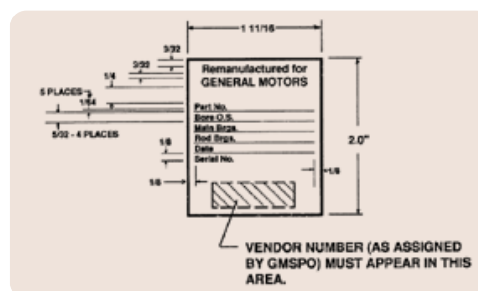
GMSPO changed suppliers for the 4.3L (L35, LB4, LF6) GM Goodwrench engine assemblies during 1999 and has instituted several quality improvement items during this change-over. The cut-off date for the latest of all improvements was December 1999.

Bulletin 00-06-01-019 has been released to help identify and resolve oil consumption concerns of the 4.3L remanufactured engines. To aid in the process of continuous improvement for this engine series, you are asked to provide the Serial number: 8 digit number and the engine build date sequence number information on the Repair Order in the event you need to replace a 4.3L GM Goodwrench engine. This information can be read from the engine ID tag.
