What Happens When a Radio is Swapped?

Techline News

GM TechLink is a monthly magazine for all GM retail technicians and service consultants providing timely information to help increase knowledge about GM products and improve the performance of the service department. This magazine is a companion to the GM Edge publication.

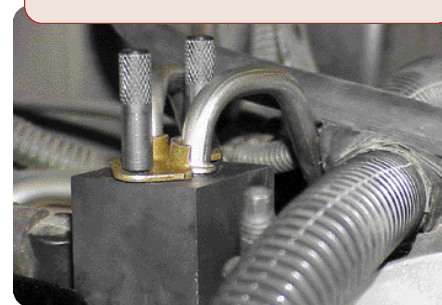
J-44466-11 Fuel Line Recirculating Block

Bulletin numbers 99-06-01-022 and 00-06-04-003 address cleaning of poppet nozzles on CPI and SCPI units. On SCPI units, the poppets can stick shut occasionally and cause driveability concerns. To determine if the poppet is stuck shut, follow the Strategy Based Diagnostic procedures in the bulletin or service manual.

Using recirculating blocks J-44466-11 and 12, the fuel system is separated into

two loops to allow cleaning and unstick at the fuel meter body. And the cleaning agent is not permitted to enter the vehicle's fuel tank, which could cause damage to the fuel pump check ball. Separating the system into two loops also eliminates the need to disable the fuel pump while running the vehicle during the cleaning operation.

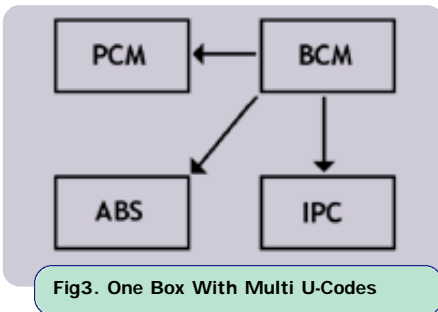
Table 3 - Scenario 3

There are multiple U-Codes stored in only one controller, no other controllers have any U-Codes stored. See Table 3

and Figure 3. Of the three scenarios this one tends to be the most difficult to figure out, so a good understanding of what happens here is critical. The following items usually surround this scenario.

A. With ignition on, the U-Codes stored will go to history. These codes may return to current once the ignition is turned to the off position and the other controllers have had a chance to power down.

To correct the problem in this scenario you'll have to figure out which controller is unable to communicate on the Class 2 bus, but your detective work should have yielded a suspect. It's now a matter of deciding why the controller is unable to communicate - no power, no ground, open Class 2 circuit, incorrect power mode signals or a defective controller.
